MASSACHUSETTS COASTAL AREA GLOUCESTER, MASSACHUSETTS

WALLACE POND OUTLET DAM MA 00162

PHASE I INSPECTION REPORT NATIONAL DAM INSPECTION PROGRAM

NEW ENGLAND DIVISION, CORPS OF ENGINEERS

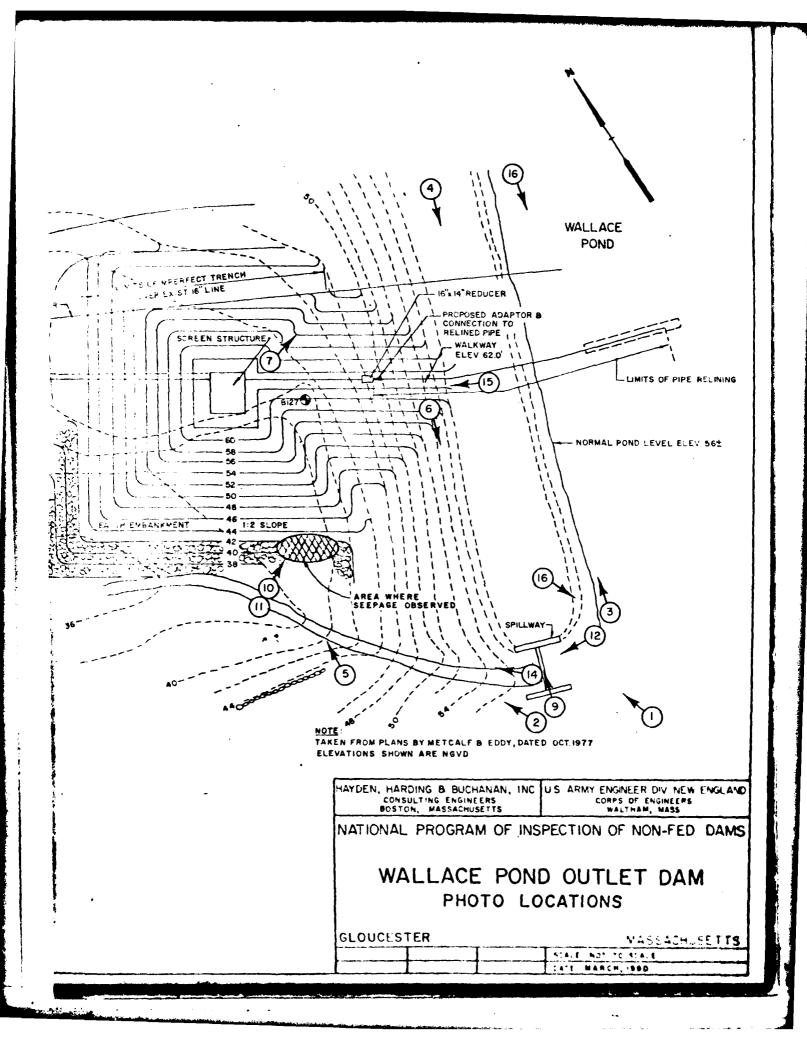
The spillway section is located at the left abutment, as shown in photograph 1. The floor of the spillway channel is bare soil with no lining to protect against erosion; however, the soil in the floor of the channel does not appear to be highly susceptible to erosion. There is a stone masonry weir at the spillway crest, as shown in photograph 9. The spillway originally contained provisions for flashboards. However, the deteriorated condition of the metal pins at the crest now restricts their usage. The floor of the spillway approach channel is strewn with several large pieces of driftwood, as is visible in the photographs.

The right spillway training wall is constructed of mortared stone masonry. The upstream end of the right spillway training wall is collapsed. A bedrock outcrop at the left abutment forms the left wall of the spillway, as shown in photograph 1. The bedrock is jointed and blocky, and appears to have eroded back about 20 feet into the abutment at the centerline of the dam. The apparent erosion is above the crest elevation. No loose rock that might fall and block the spillway was observed.

PHOTO NO. 1 - Spillway intake at the left abutment.

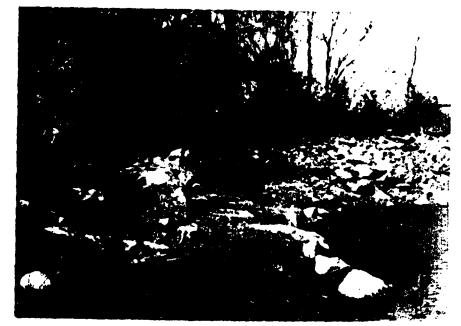
PHOTO NO. 1 - Spillway intake at the left abutment.

The spillway, approach and discharge channel are in need of repair. The stone masonry spillway needs resetting and pointing. The channels should be cleared and reshaped and lined to prevent possible erosion.

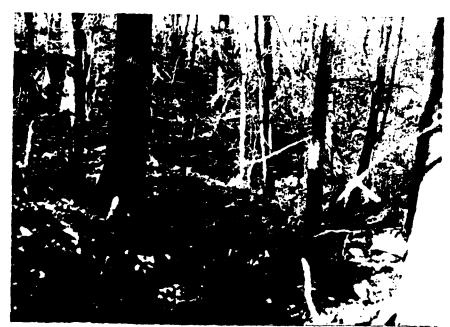
PHOTO NO. 2 - Downstream spillway channel, viewed from the spillway crest.

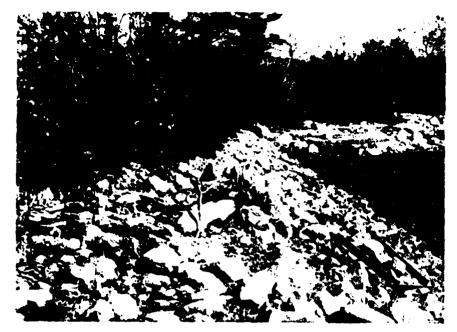
The upstream slope of the dam is protected by riprap up to about 3-4 feet below the crest, as shown in photograph 3. The riprap is in generally good condition; however, occasional windows were observed in the riprap, as can be seen in photograph 3. The upper 3-4 feet of the upstream slope above the riprap is overgrown with brush.

PHOTO NO. 3 - Upstream slope of the Dam, viewed from the left abutment.

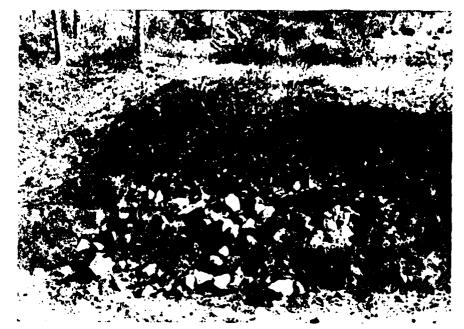
PHOTO NO. 7 - Downstream slope of the Dam, looking toward the right abutment from the Screen House.

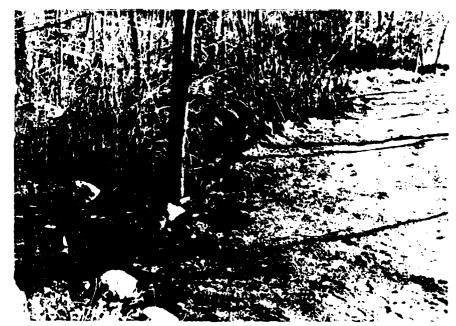
Standing water was observed on the right side of the access roadway near the right abutment, as shown in photograph

PHOTO NO. 8 - Standing water on the right side of the access roadway, approximately 100 feet downstream from the right abutment.

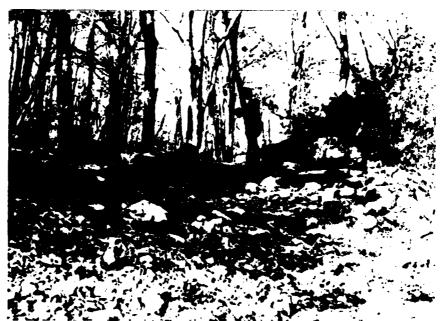
spillway were found to be mostly rusted away during the field inspection. The spillway has a maximum capacity of 85± cfs before the dam, crest elevation of 60, would be overtopped. Photographs 1 and 12 in Appendix C show various aspects of this structure. Hydraulic calculations for the spillway are contained in Appendix D.

PHOTO NO. 12 - View of spillway taken from upstream embankment looking toward crest.

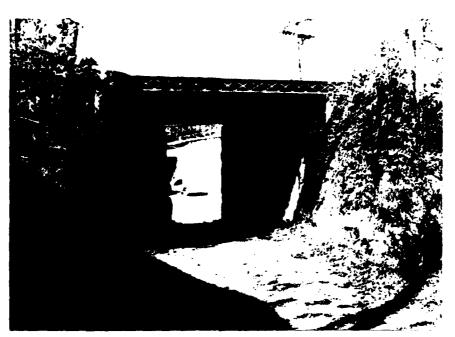
PHOTO NO. 13 - View of opening in railroad embankment for access road to Dam. The opening is 10.3 feet high by 15.5 feet wide. Most of the outflow from the test flood and at least 25% of that from a possible Dam failure could be discharged through this opening. The building showing in the opening is the water treatment plant, across Magnolia Street.

PHOTO NO. 13 - View of opening in railroad embankment for access road to Dam. The opening is 10.5 feet high by 15.5 feet wide. Most of the outflow from the test flood and at least 25% of that from a possible Dam failure could be discharged through this opening. The building showing in the opening is the water treatment plant, across Magnolia Street.

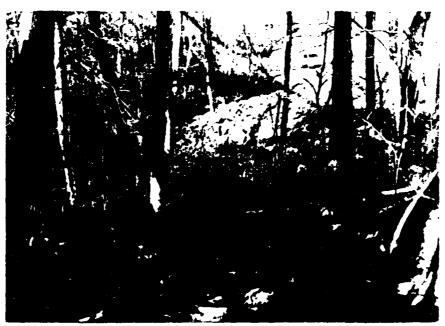
PHOTO NO. 14 - Looking at overflow area on downstream face of Dam from spillway. There is no defined downstream outlet channel from the spillway. Note logs, branches and other debris on downstream face. The riprap protecting the toe of the embankment for the Screen House is shown in the upper middle right portion of the Photo.

of Dam from spillway. There is no defined downstream outlet channel from the spillway. Note logs, branches and other debris on downstream face. The riprap protecting the toe of the embankment for the Screen House is shown in the upper middle right portion of the Photo.

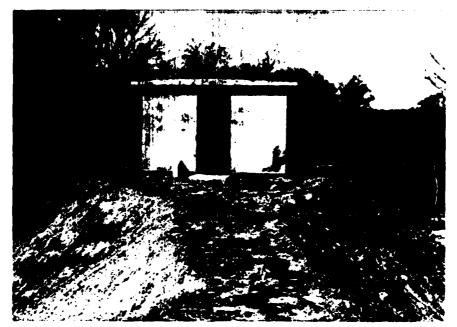
PHOTO NO. 15 - View of Screen House and embankment taken from Dam embankment.

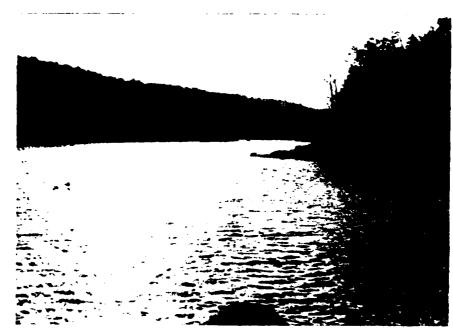
PHOTO NO. 16 - View of Wallace Pond looking eastward from crest of Dam. On the day this photo was taken, the Pond water level was about 11 feet below the crest of the Dam.

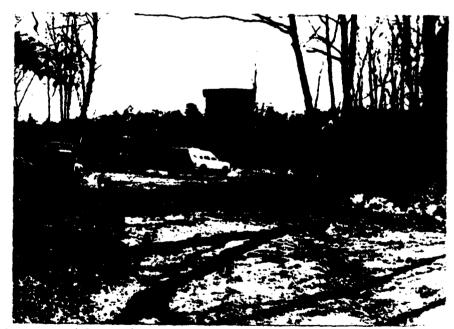
PHOTO NO. 18 - View of downstream side of Dam taken from access road. Note lack of grass for slope protection and erosion on Screen House embankment. The spillway for the Dam is located to the right of the Screen House in Photo. The Dam embankment is shown to the left of the Screen House.
